New Mexico Mining Minerals Division
Abandoned Mine Land Program
Uranium Mine Reconnaissance Files

RECONNAISSANCE REPORT XEROX COPY FORM
ABANDONED MINE LAND PROGRAM
New Mexico Mining And Minerals Division

New Mexico Mining Minerals Division
Abandoned Mine Land Program
Uranium Mine BLM Surveys

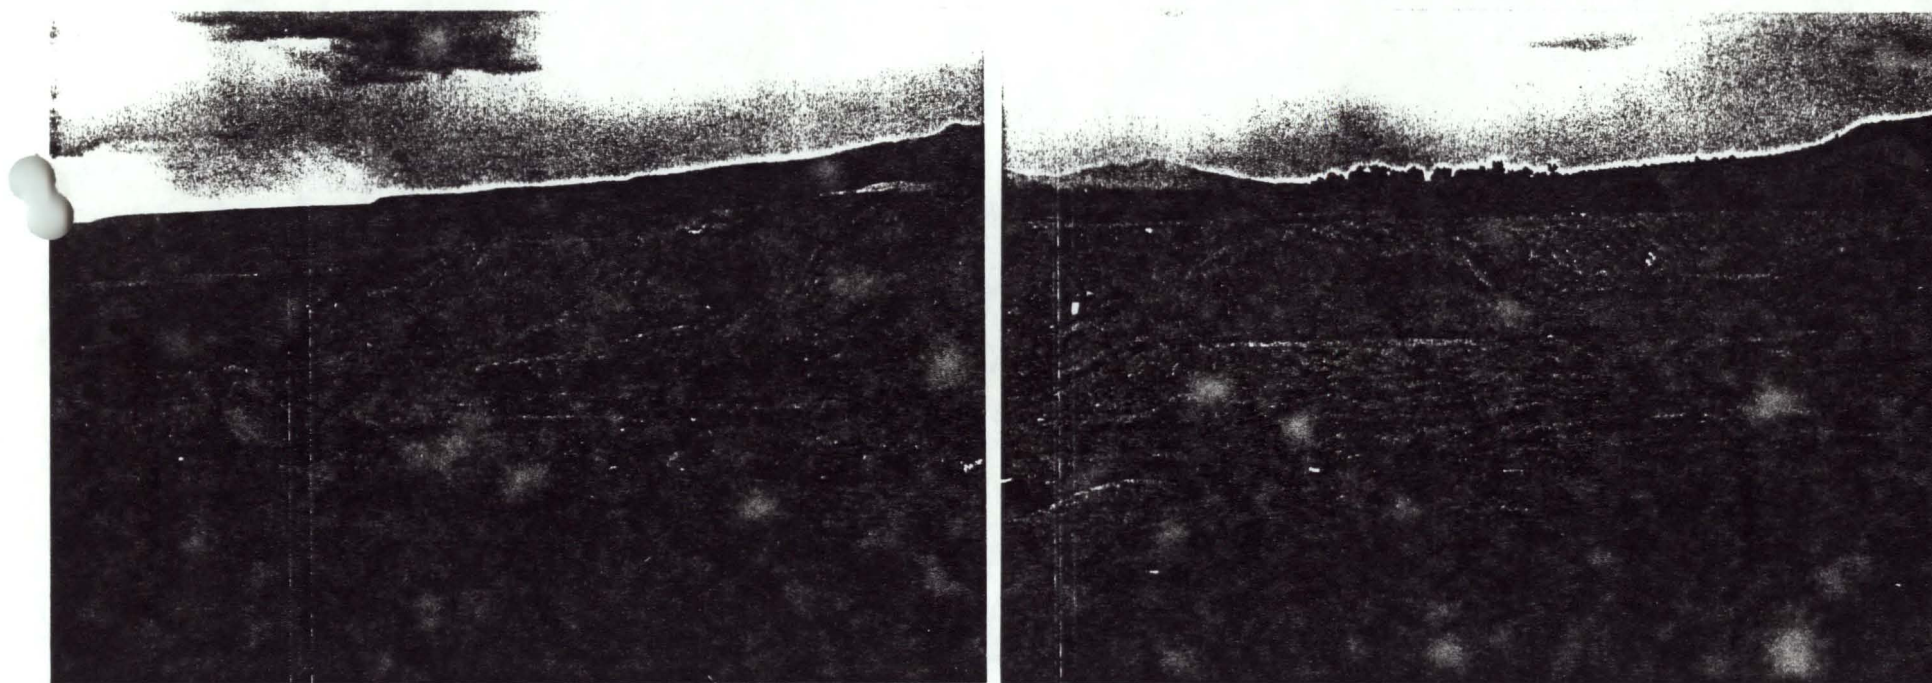
View to southeast and south from Camera Point 4 (CP-4). Left to right - approximate limit of mine waste dump, showing erosion of face of dump.

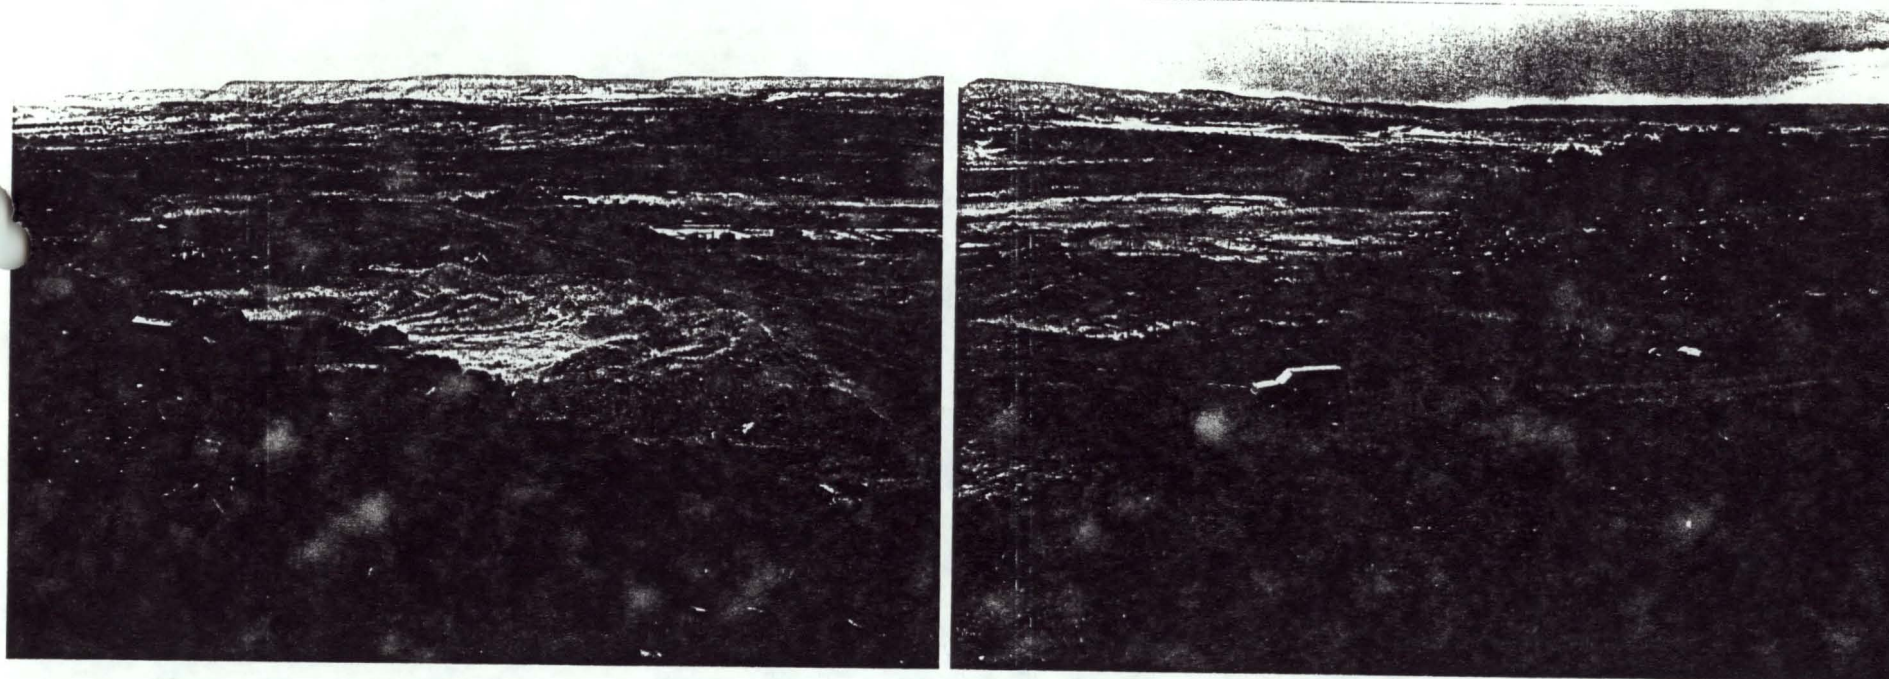
View to north-northeast from Camera Point 1 (CP-1). Overview of main shaft and surface workings (see Appendix 5): Background, left to right - approximate limit of mine waste dump (leach pads and settling ponds not visible); middle ground, left - debris and warehouse site; middle ground, center - machine shop foundation and fenced enclosure around main shaft; foreground, left - upper mine waste dump. Mine access road crosses from upper left to middle right (northwest to southeast).

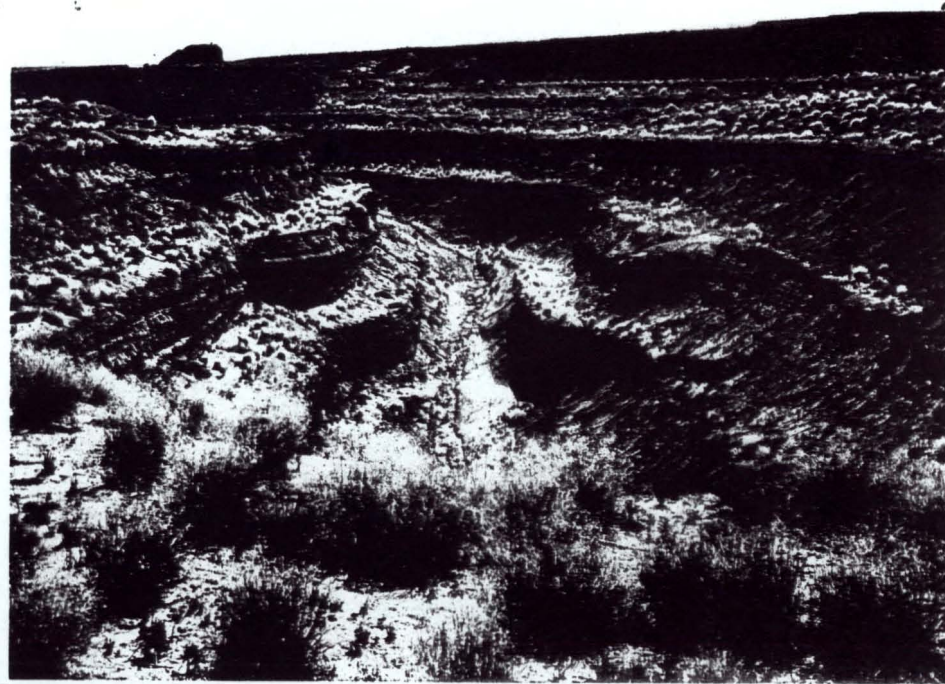
DESCRIPTION: View from west side of mine directly over
adit opening. Note eroding benches and drainage down slope
access. Slopes being revegetated.

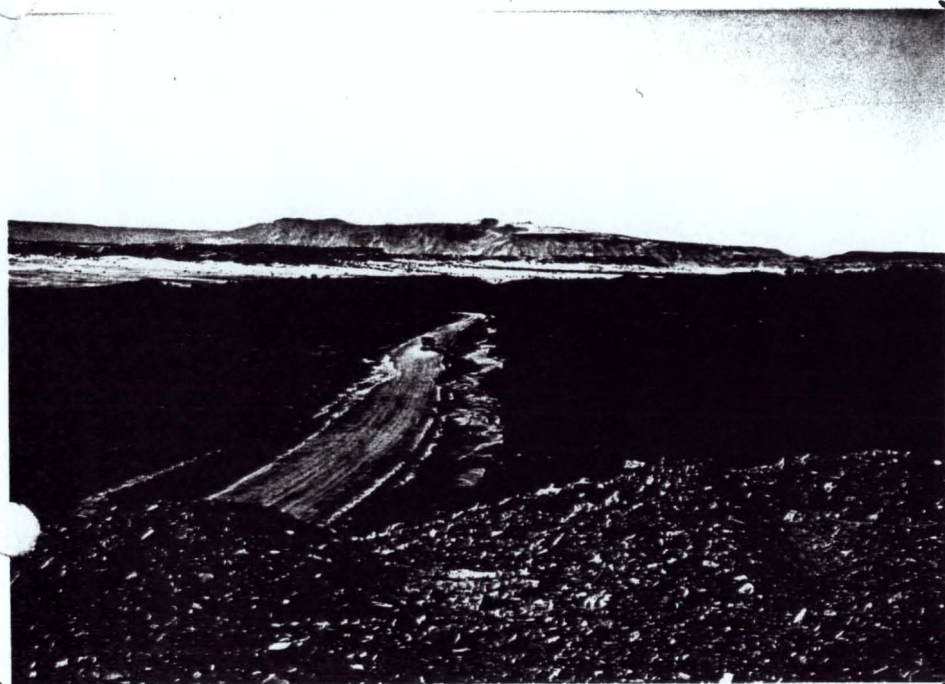
DESCRIPTION: View of access road leading into study
area from top of waste pile. Note drainage along road
which runs along the base of the waste pile. No increased
radiation readings were found in the drainage. View is
facing SE.

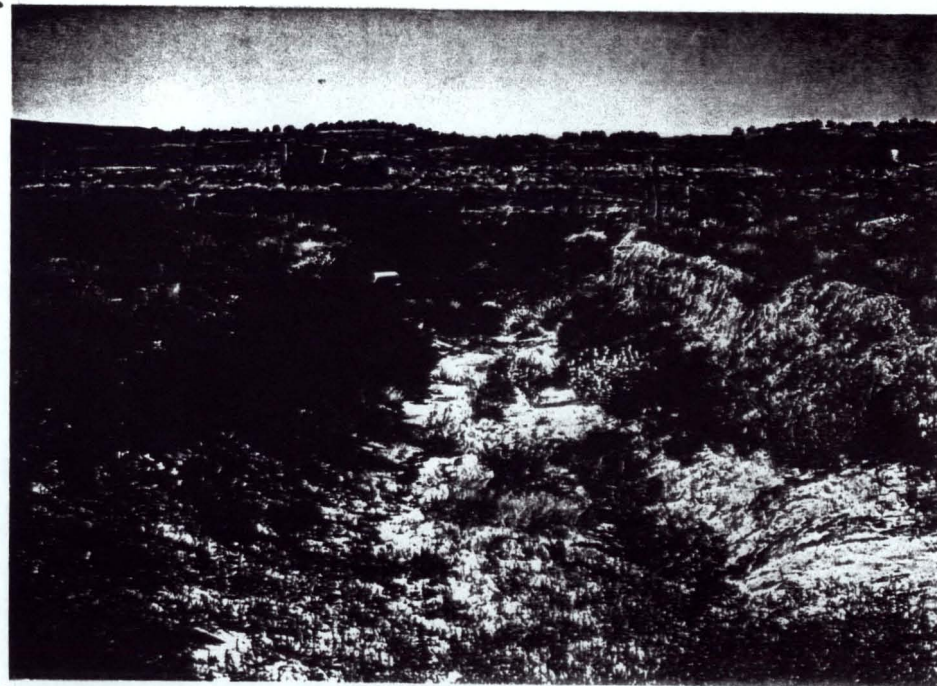
DESCRIPTION: Possible subsidence 300 feet SW of adit.

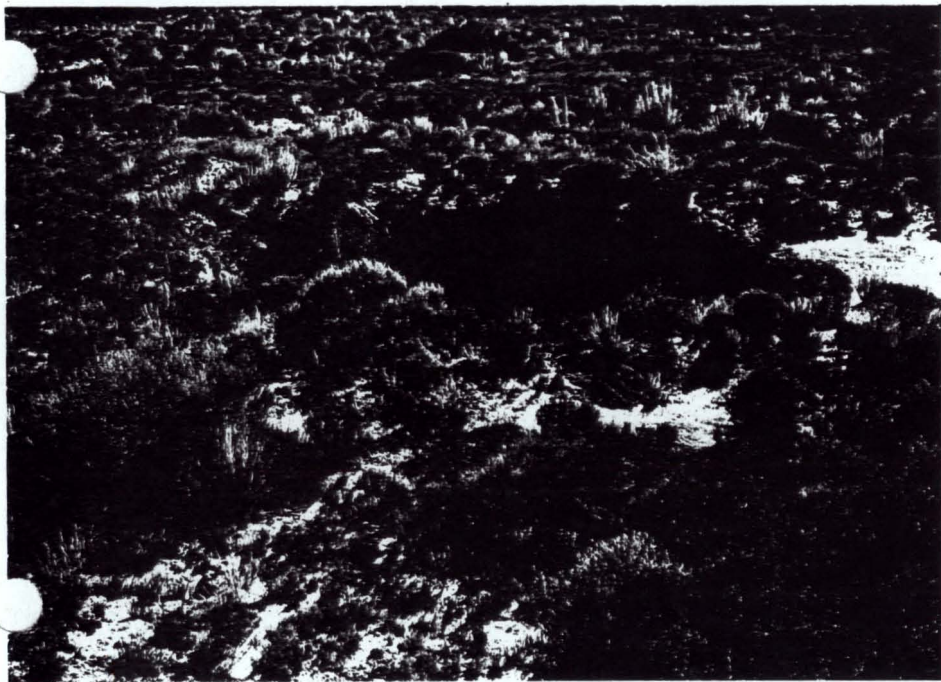
DESCRIPTION: Subsidence west of the mine. Dead cow
was found at this site in hole. Death caused when cow
could not climb out of hole.

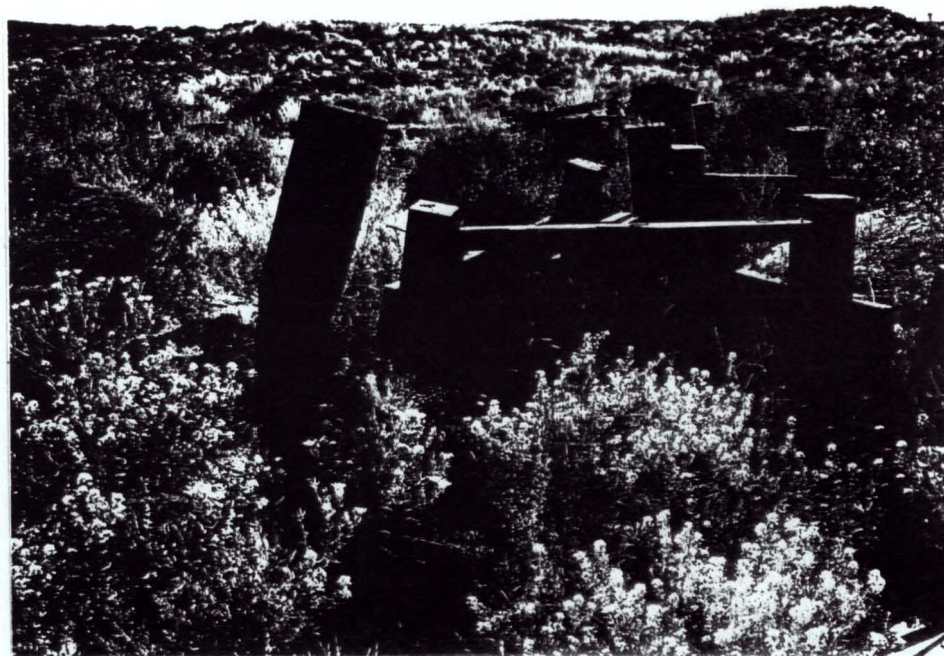
DESCRIPTION: View of collapsed adit. Not waste piles
in background.

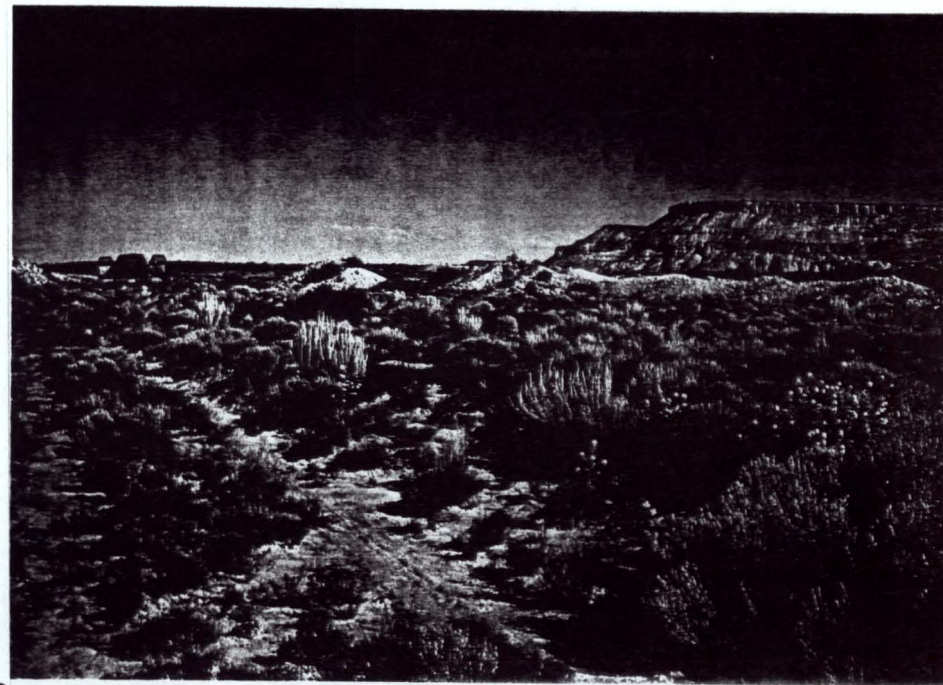
DESCRIPTION: View from east showing north side of
waste pile area. Note lack of vegetation on waste piles.
Area just off right of photo is slope into drainage. No
apparent erosion.

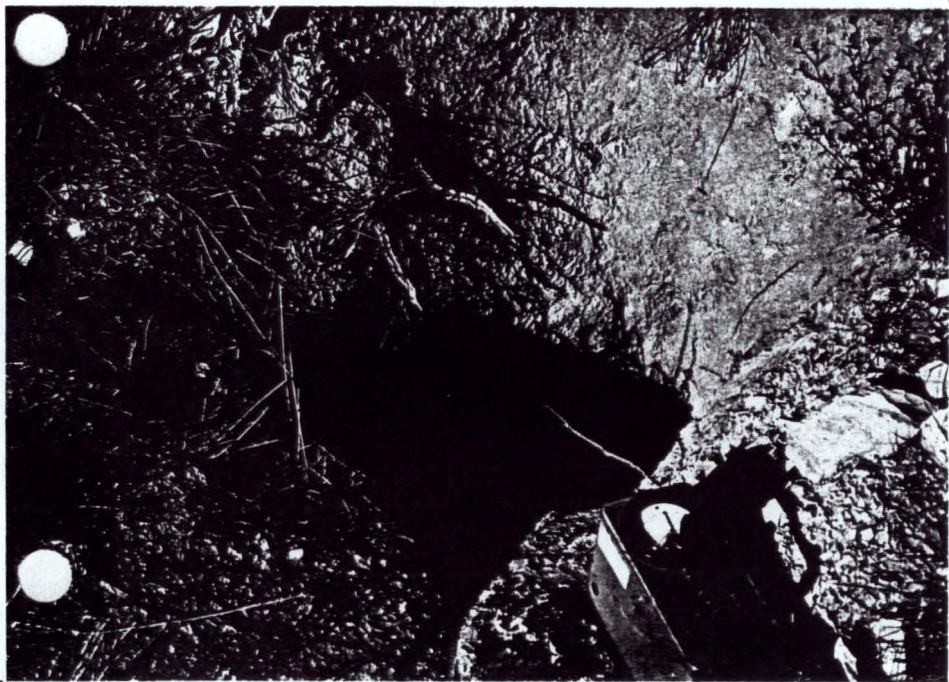
DESCRIPTION: Subsidence hole found near waste pile in
arroya. Hole is 2-3 feet across at surface. Hole is
just north of shaft.

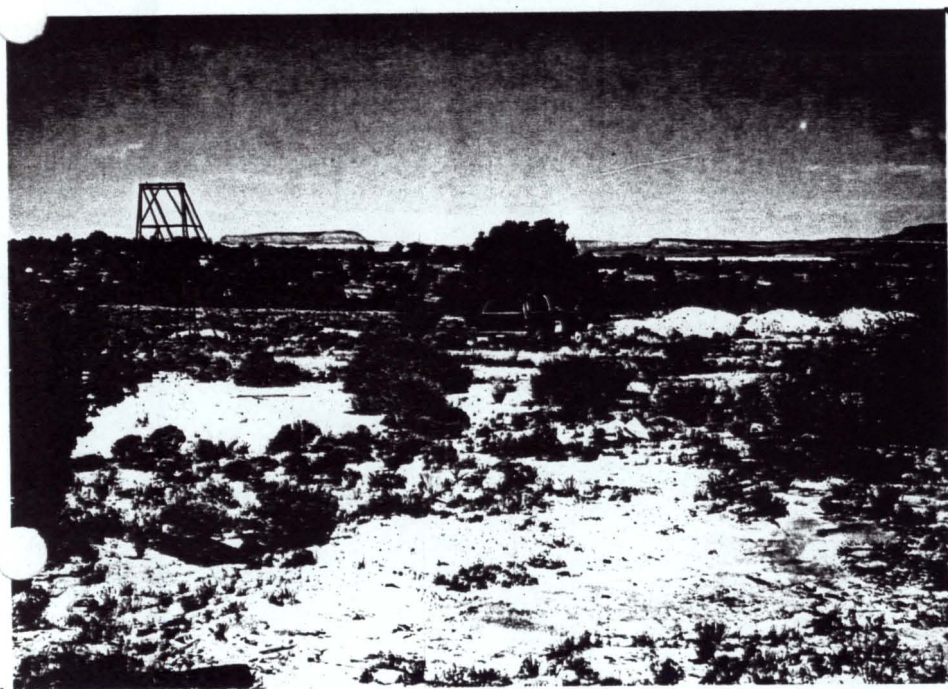
DESCRIPTION: General view of mine site showing frame
left and waste piles. Note vegetation on site.

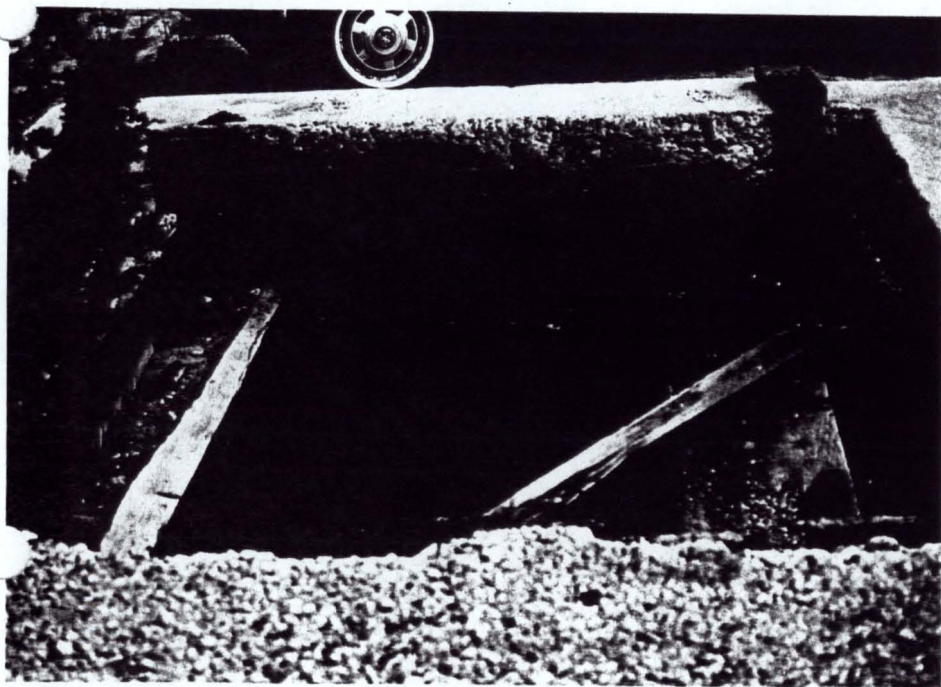
DESCRIPTION: View of 6' x 6' shaft opening. Note
boards of opening. Boards were found to be rotten.

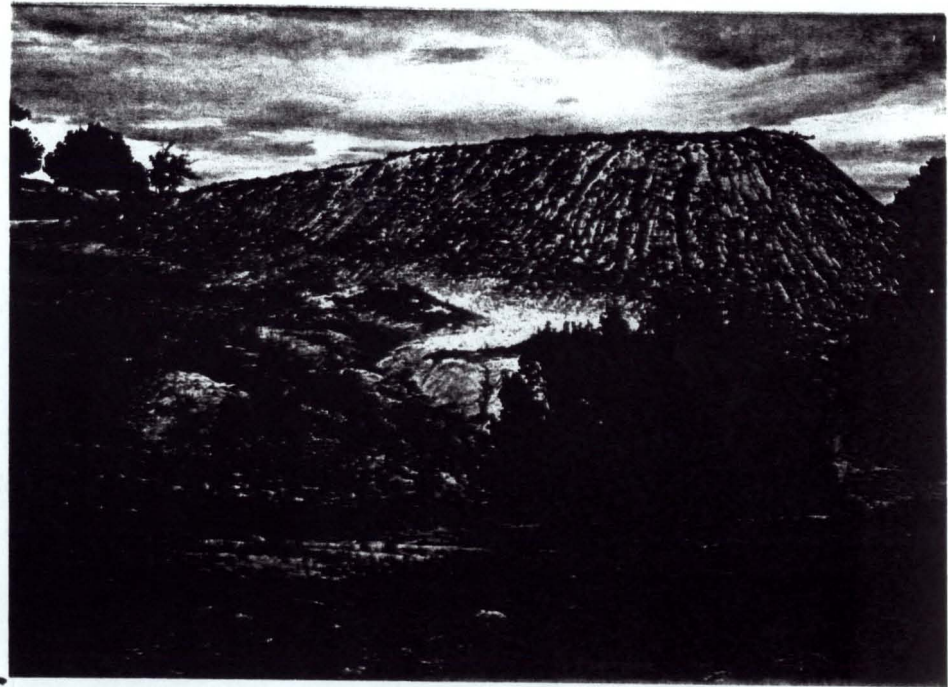
DESCRIPTION: Closer view of waste pile located
directly above arroyo. Note drainage patterns.

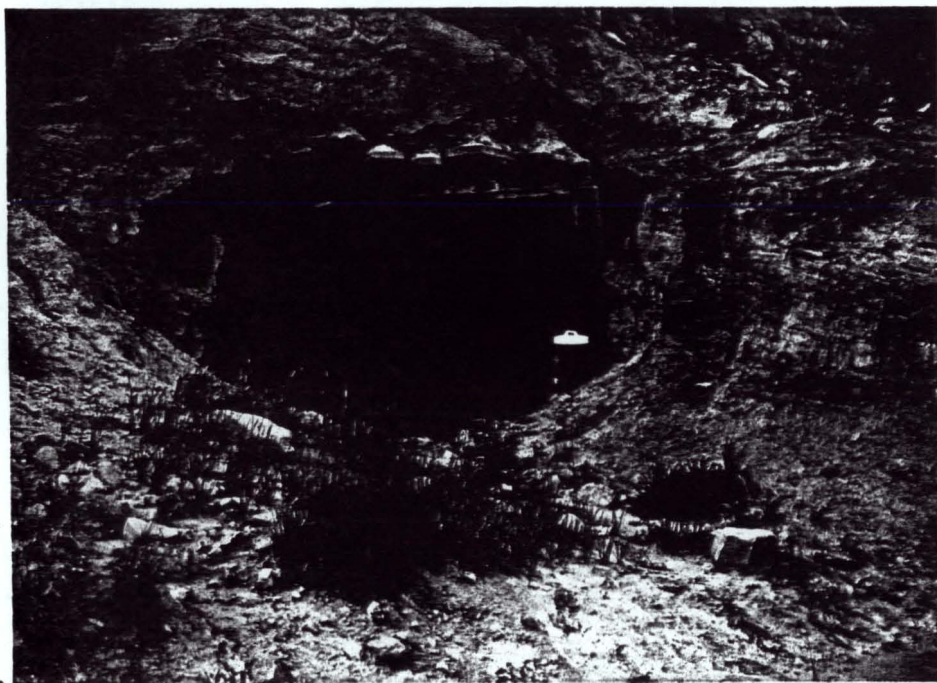
DESCRIPTION: Western most portal opening, higher radiation
readings were found at each entrance that was open. Possibly
gas coming from mine is radioactive.
